## DMR Series

### [CS800 Firmware Upgrade Guidelines \(S1.01.04 Main and R1.00.02 Front Panel\)](#)

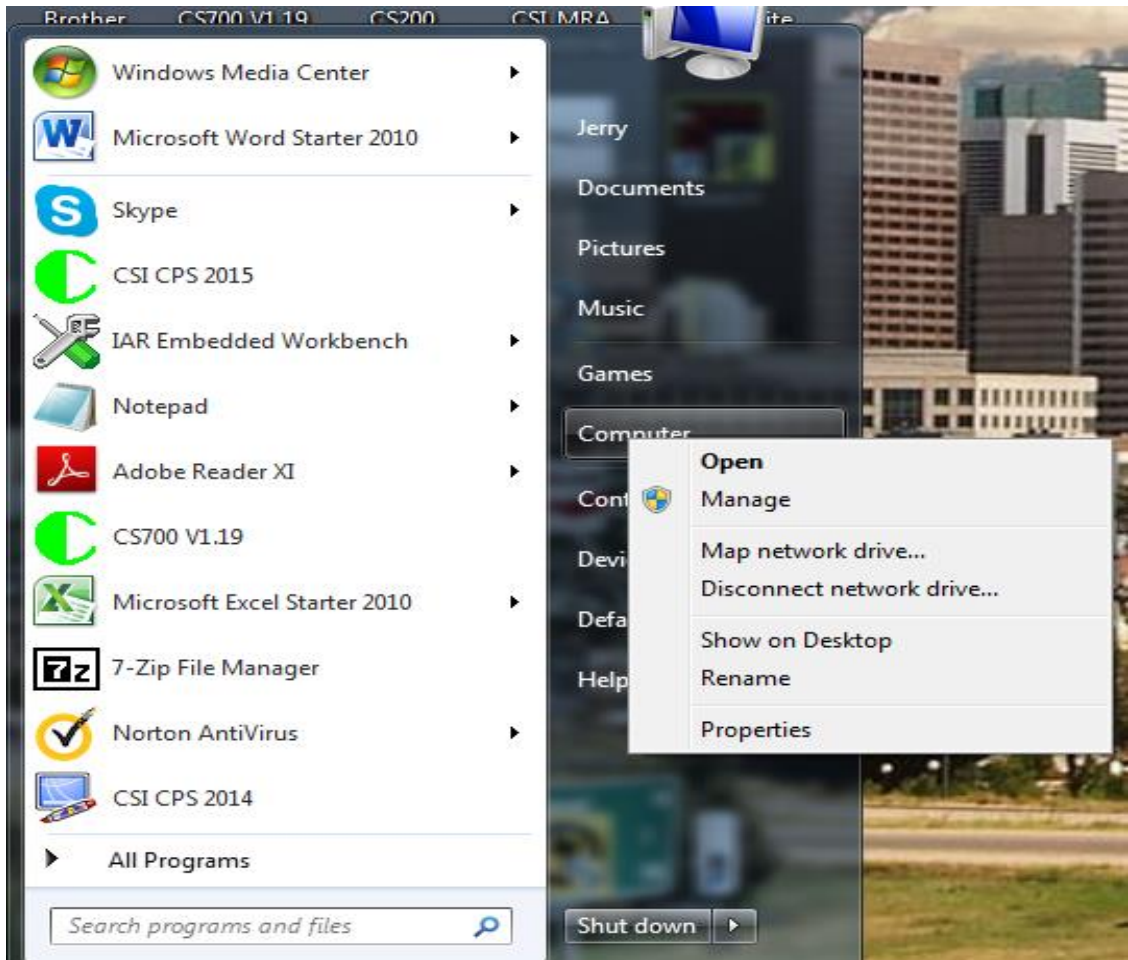
- 6) Please insert your RJ45 programming cable on the front USB connector of your desk computer or any USB connector of your laptop for one or two minutes (to verify that the USB to UART conversion IC runs correctly).
- 7) Click your computer's 'Start' button, find 'Computer' and right click.

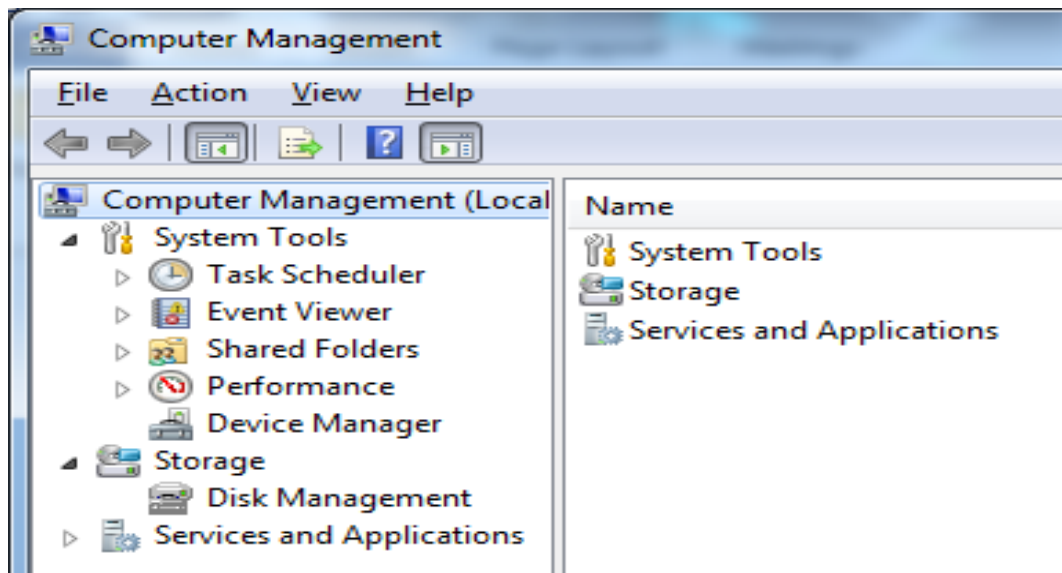
8) Double Click Manage with the left button and you now get the following:

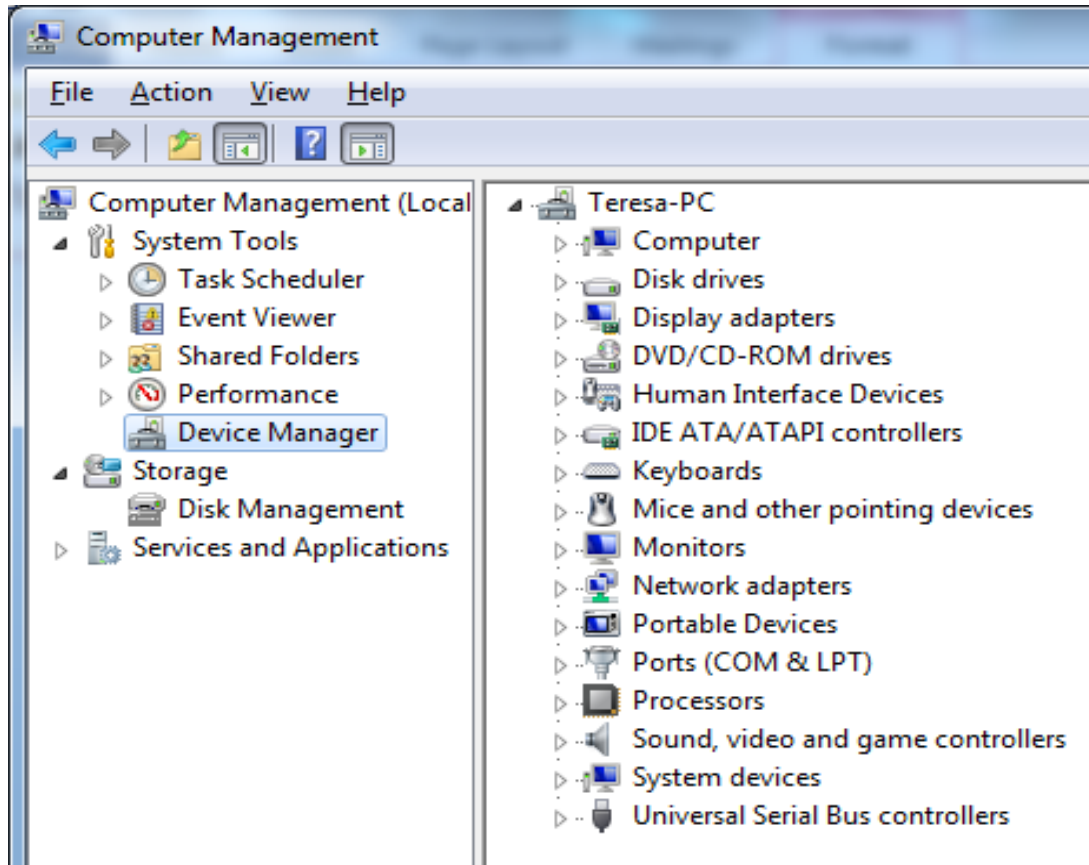
9) Double Click 'Device Manager', and you get:

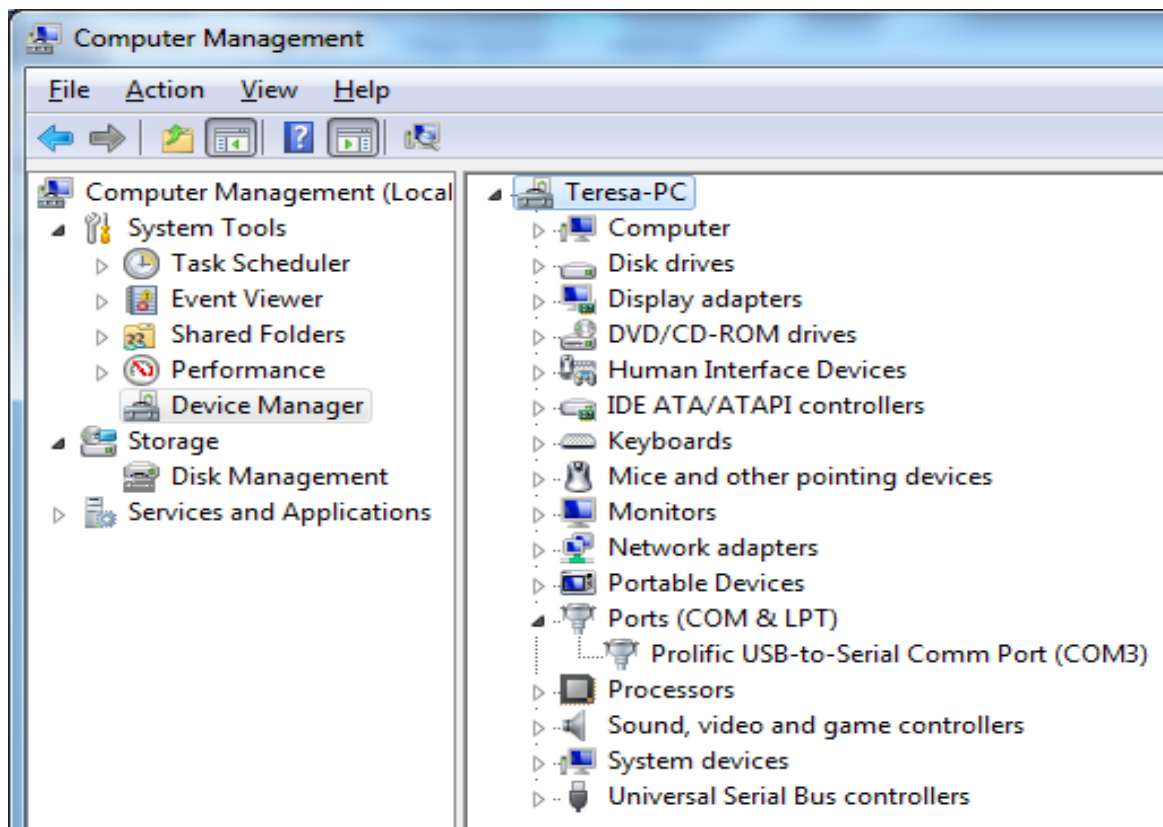
- 10) expand the 'Ports (COM & LPT)' menu, and find 'Prolific-USB-to-Serial Comm Port (COM#)'. Make a note of the COM port # as it will be needed later in the upgrade program.

Note in this computer it says COM3

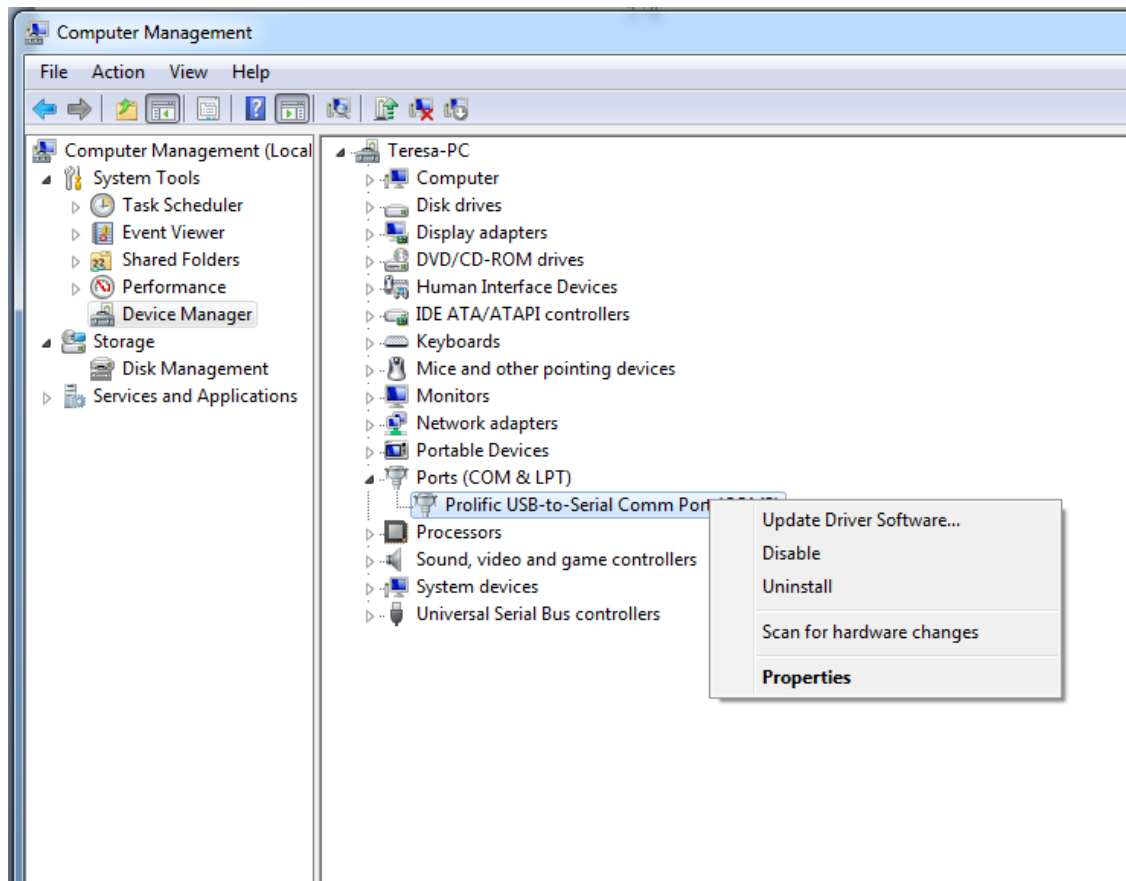
11) Right click 'Prolific-USB-to-Serial Comm Port (COM#)' and select 'Properties'.

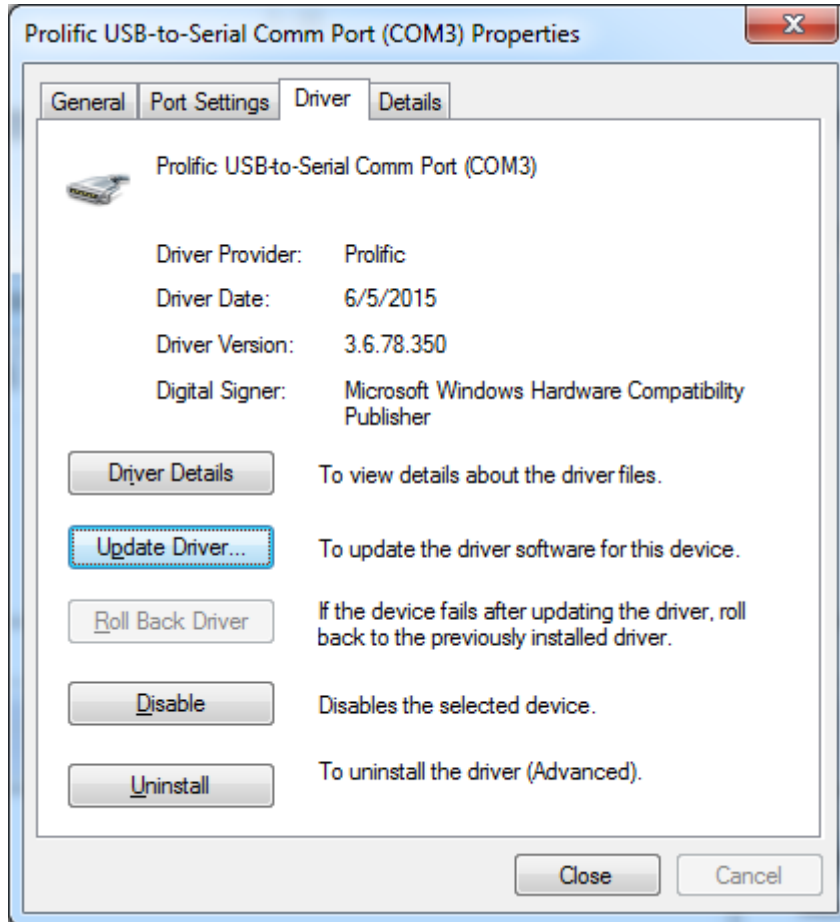
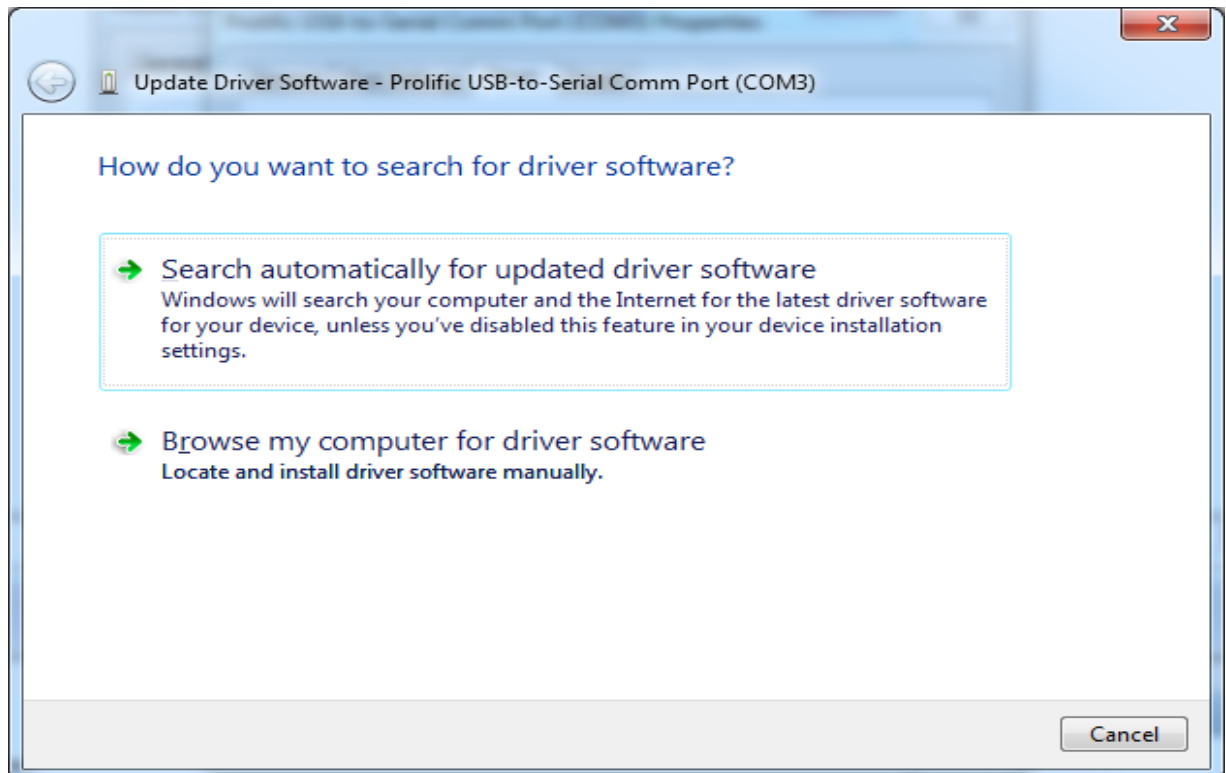
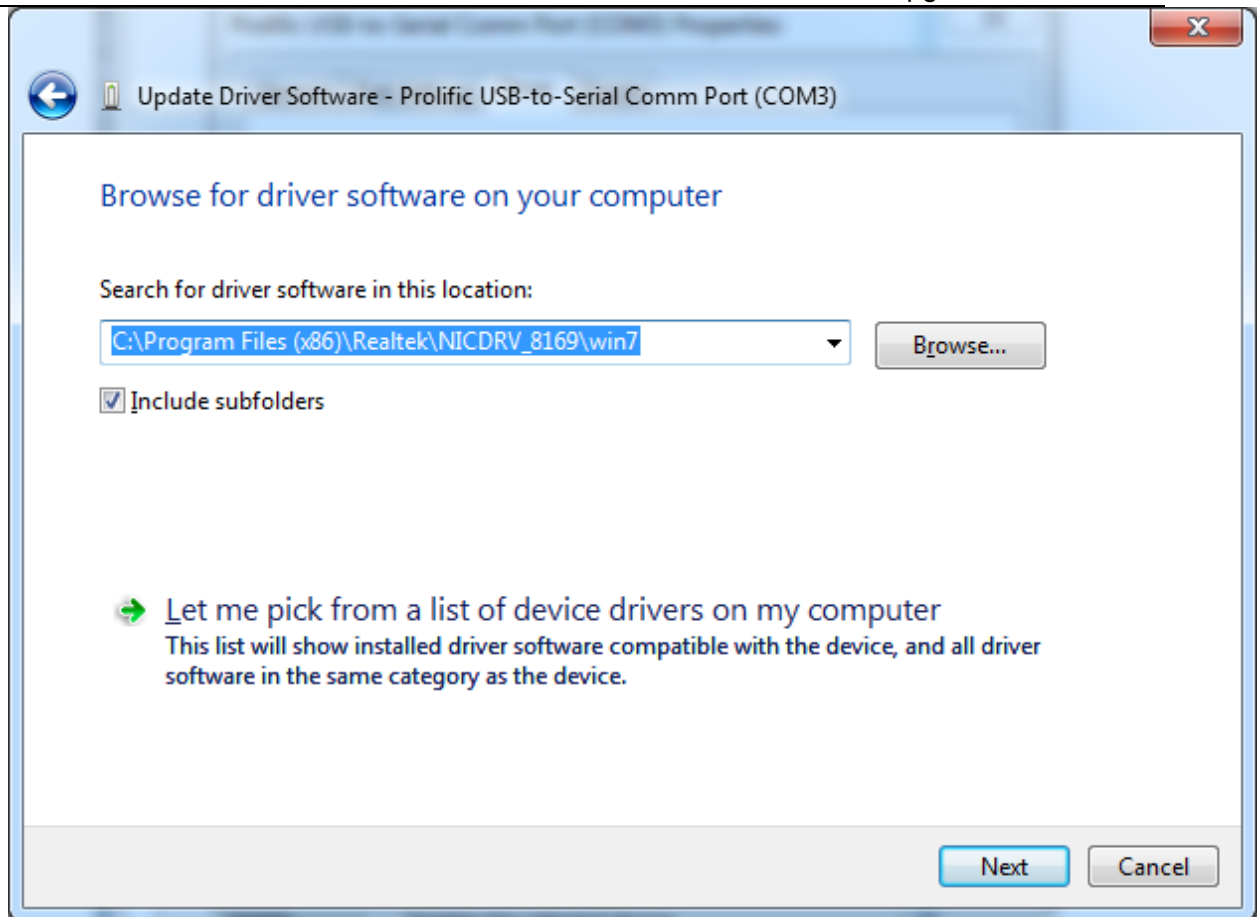
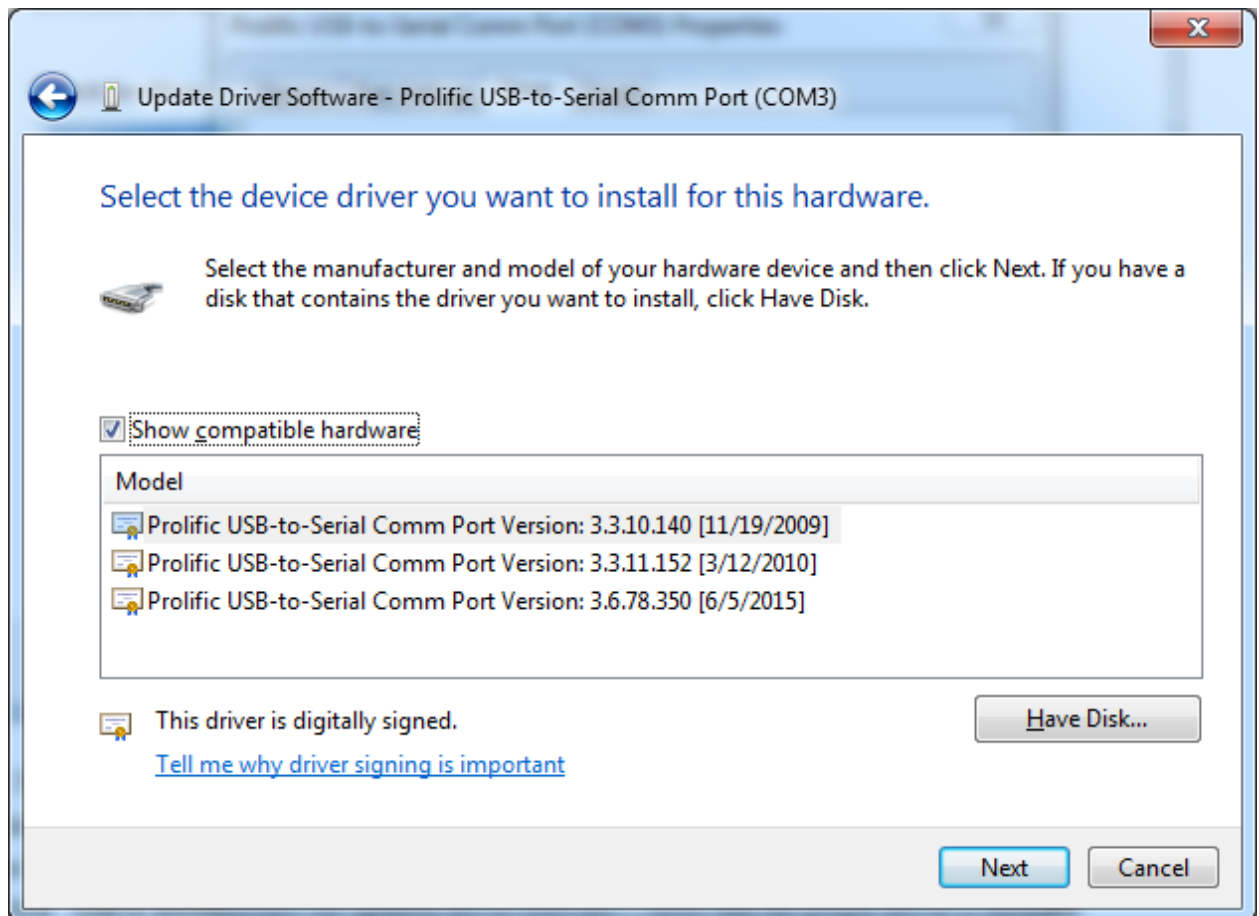
- 13) If the driver version does not match the number above, click the 'Update Driver' button, the 'Browse my Computer' selection, and 'Let me pick from a list ...' selection.

If 3.6.78.350 is available in the displayed list, highlight it and select 'Next'. Clicking next will install

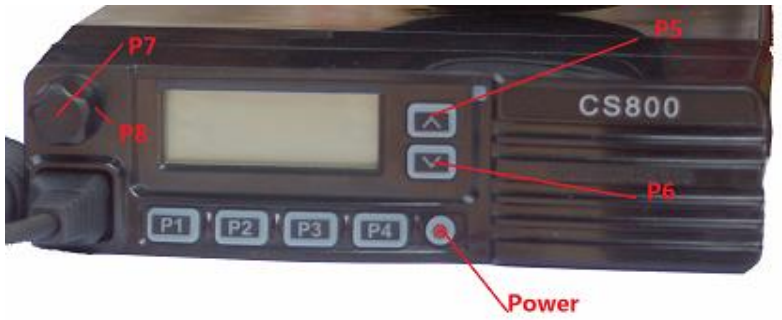
- 1) Please insert your RJ45 programming cable on the front USB connector of your desk computer or any USB connector of your laptop for one or two minutes (to verify that the USB to UART conversion IC runs correctly).
- 2) Press and hold P7 (do not spin) and then press 'Power', the RED LED will be lit and the front MCU will enter 'Program Mode'

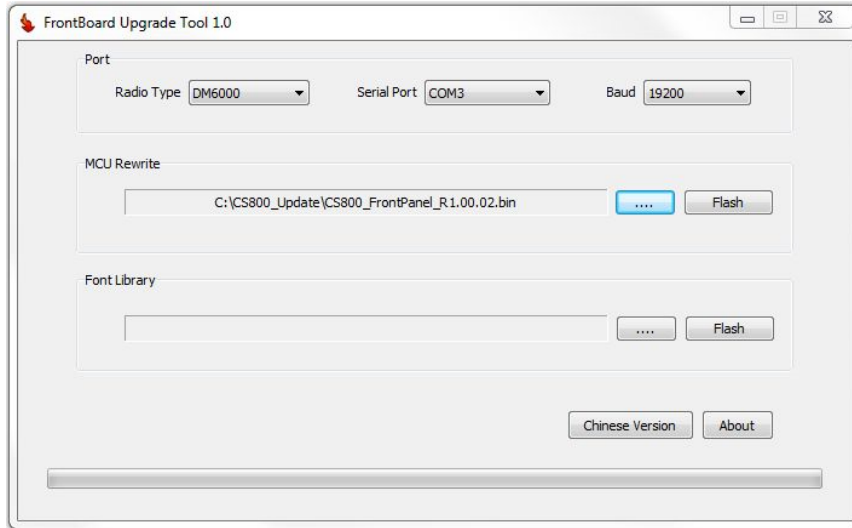
- 3) Run 'MobileFrontPanelUpgradeTool R1.0.exe' and set the correct serial port and baud rate (based on the information you obtained in step 5 of the driver installation procedure. Click the '...' button in the 'MCU Rewrite' field and load 'CS800\_FrontPanel\_R1.00.02.bin'. Click the 'Flash' button in the same field to run the update. **Please keep the radio and cable on a firm, stable surface to avoid inadvertant disconnections during the update.**

- 4) After the 'Upgrade Success' prompt from the PC, you can press the POWER key to power off the radio, disconnect the cables, and then power on it to check. Please note you need to upgrade the mobile MCU before you can operate the front panel keys, as there has been a change to the protocol of the key-values.
