DMR Series

[CS800 Firmware Upgrade Guidelines \(S1.01.04 Main and R1.00.02 Front Panel\)](#)

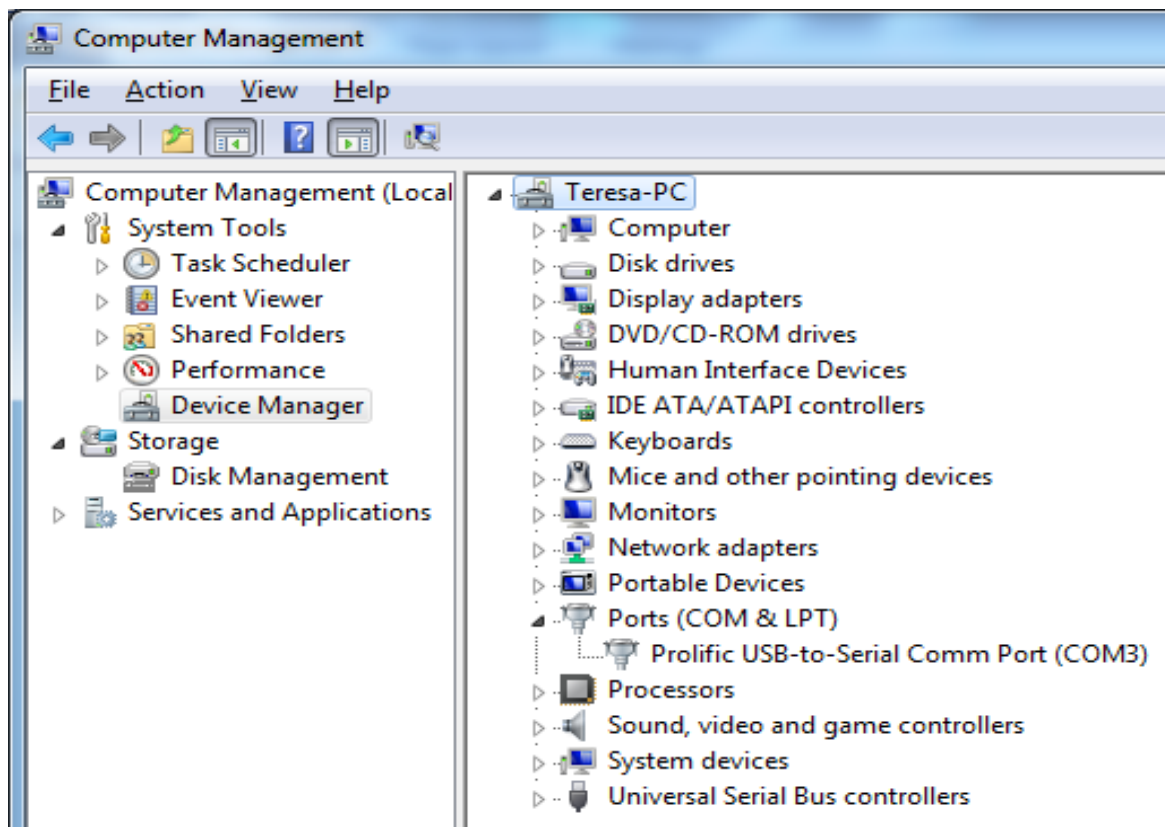
- 10) expand the 'Ports (COM & LPT)' menu, and find 'Prolific-USB-to-Serial Comm Port (COM#)'. Make a note of the COM port # as it will be needed later in the upgrade program.

Note in this computer it says COM3

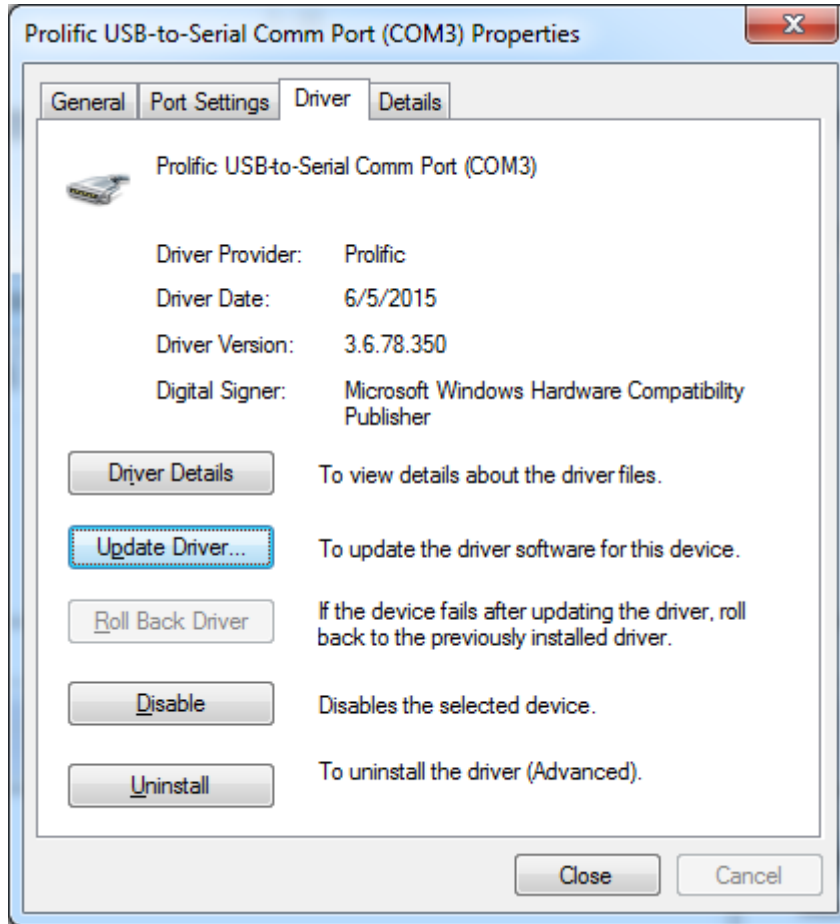
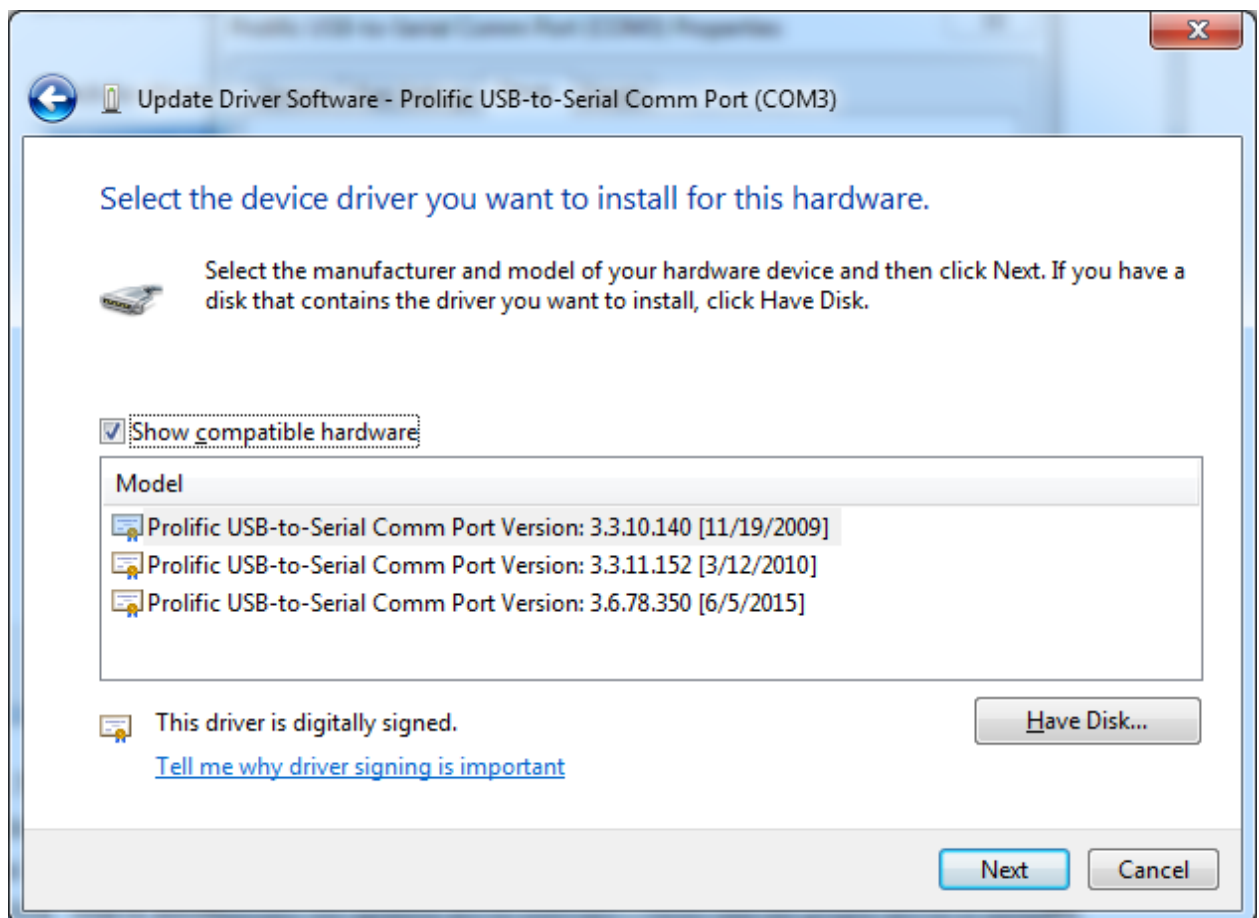
- 13) If the driver version does not match the number above, click the 'Update Driver' button, the 'Browse my Computer' selection, and 'Let me pick from a list ...' selection.

If 3.6.78.350 is available in the displayed list, highlight it and select 'Next'. Clicking next will install
